I have taken screen shots of historical David Pond topo maps. To get better clarity of the maps in question go to link below, then type in David Pond ME in top right search.

1910 topo David Pond

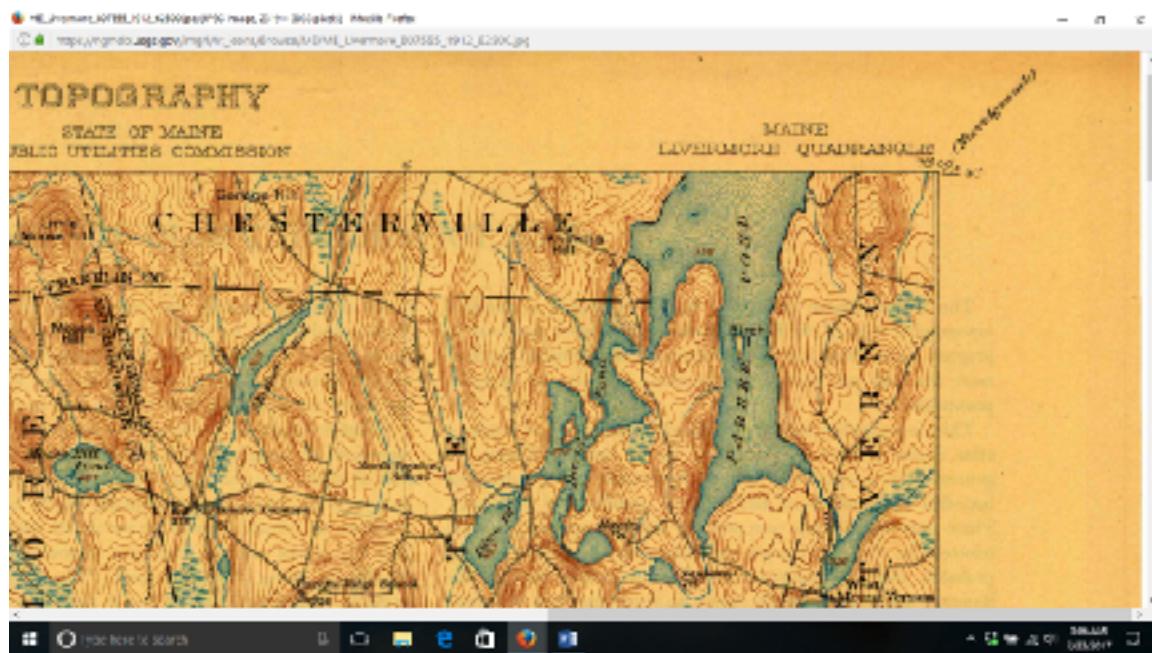
1912 topo shows same

- Outlet dam/impoundment at Sandy River Rd
- Higher water levels than current indicated by
 - by much wider/more water at site of current impoundment to Sandy River Road
 - shows much more water in cove where water comes into David from Tilton than today's levels
 - Of the 6 current wetland areas designated on David Pond by US Fish and Wildlife Service, only one marsh area designated in 1910

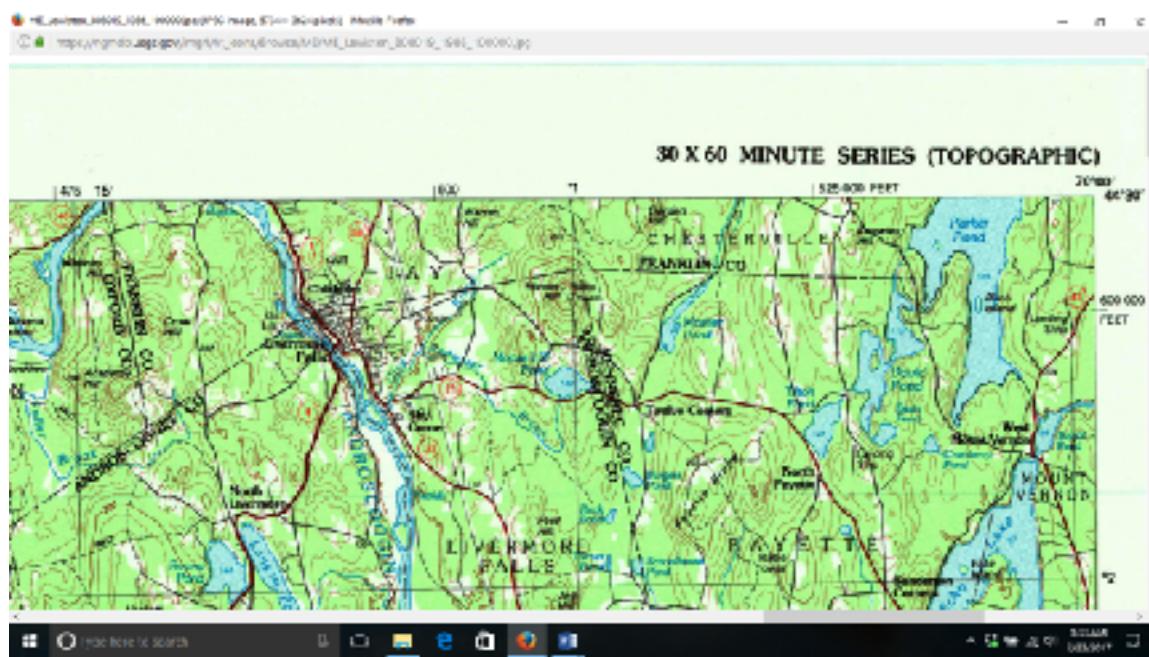
1986 topo map. This map is particularly important in that the National Resource Protection Act was passed in 1988. This is the legislation DEP is citing that states it's illegal to dam or block flow of water from any Maine stream, lake or pond.

- Shows dam/impoundment at outlet in Chesterville similar to present day location
